Seismic Testing of Anchor Failures on Unreinforced Masonry Buildings
Written by: Katie Chuh

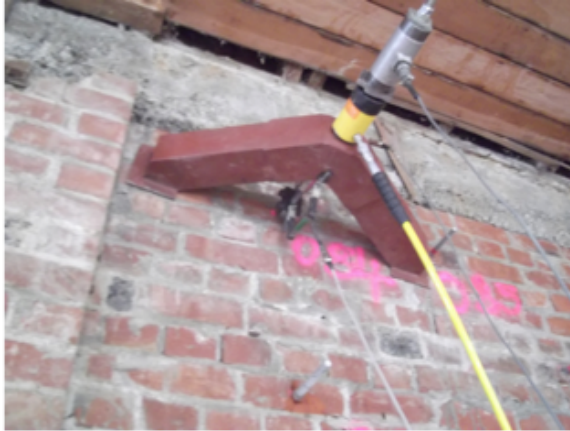
Figure 1: The steel frame testing set-up including the strain gauges and hydraulic pump.

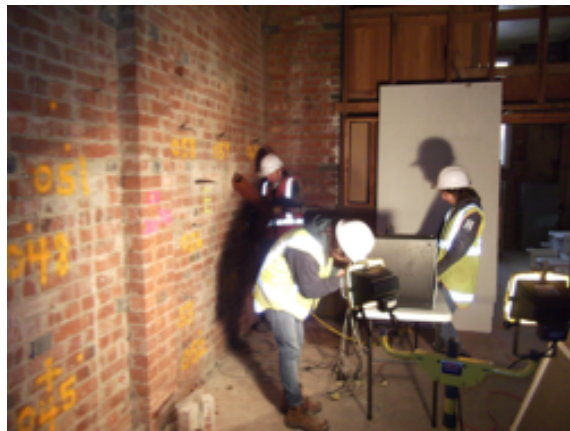
Figure 2: Overall anchor pull-out testing set up including the on site monitor and computer to record the force and displacement results.

The site for our testing was an abandoned Liquor store in Whanganui, New Zealand. The two story masonry warehouse provided the necessary space and materials needed to install 144 anchors over the week spent testing. The anchors installed ranged in rod diameter, embedment depth, angle of entry, and adhesive material used. Both 12mm and 16mm diameter threaded steel rods were drilled either 100mm, 200mm, or 300 mm at a 22.5 degree or 0 degree entry angle in order to test all different types of installation techniques recorded in the damaged buildings. Epoxy or grout was used as the adhesive for the anchors, representing the intended decade at which the buildings were constructed. Once cured, the anchors were loaded with tension using a hydraulic pump and steel test frame (Figure 1). The maximum pull-out force was derived using a calibrated pressure gauge. The frame used was specifically designed to clear the 45 degree zone of influence at the largest depth of 300mm. Two strain gauges were also implemented in testing device to accurately measure the distance the rod was displaced. Figure two illustrates the set-up for the anchor testing.
